**NATIONAL FISH AND WILD LIFE FOUNDATION**

**MATILIJA DAM REMOVAL DEMONSTRATION**

**FINAL REPORT**

**MATILIJA DAM EVALUATION/DEMONSTRATION  
FINAL PROJECT STUDY**

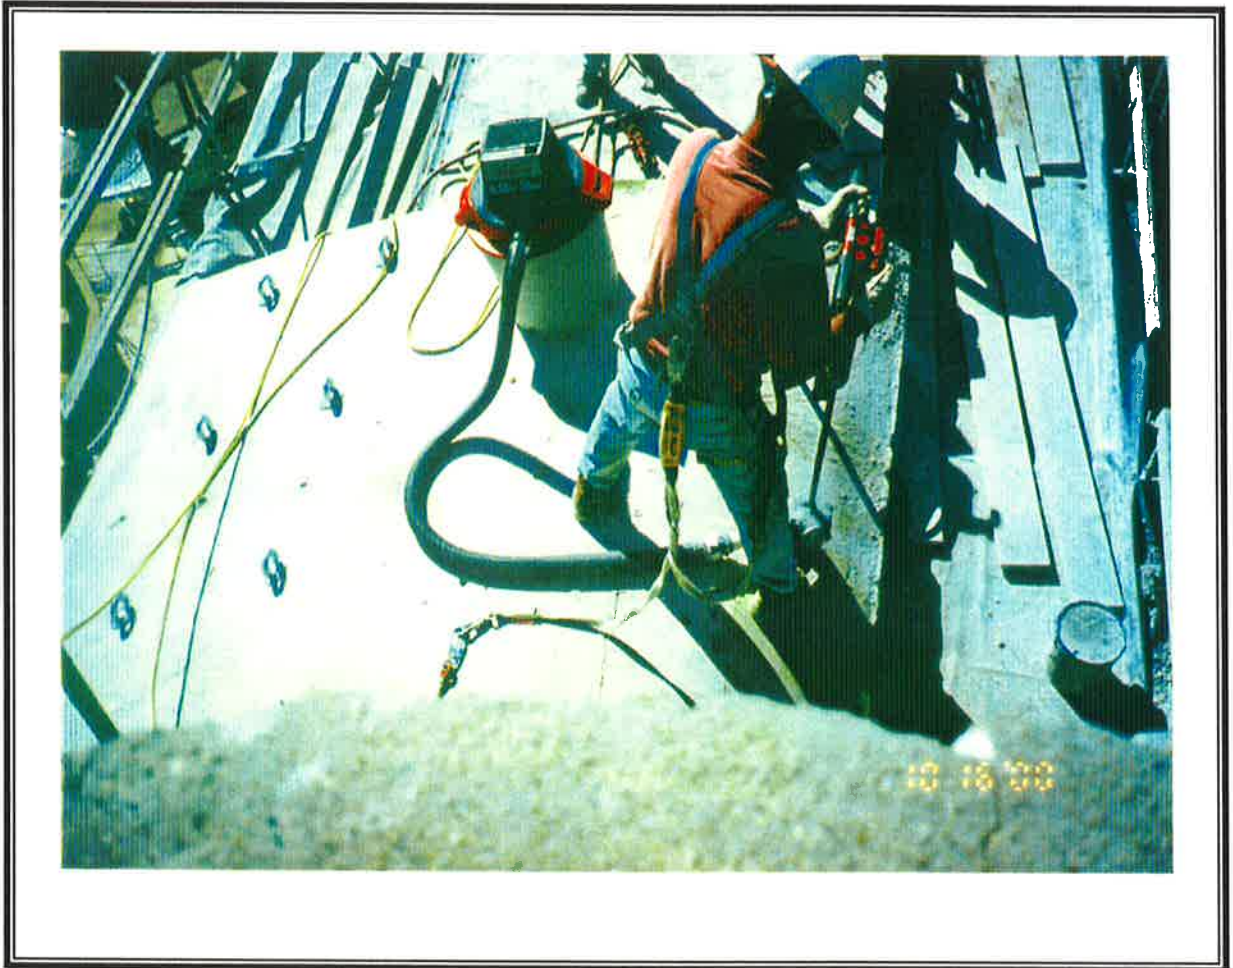
Figure 4

Dry vacuuming was used while drilling the holes.

Environmental issues associated with the saw include noise, dust, and water. Noise generated by the saw reduced drastically with distance, so the neighbors of the project were not significantly affected. Dry vacuuming was used during the drilling of the holes in this portion of the Project (Figure 4). Water was used to spray the work area and saw blade during work to cool and lubricate blade action. This required a careful collection and recirculation mechanism for the water, which involved plastic collection sheets, a pump, a generator, and a large water container where the concrete cuttings could settle for later disposal. It was imperative to collect the water rather than discharge it to the soil or surface waters due to the extremely high pH of the concrete particles.

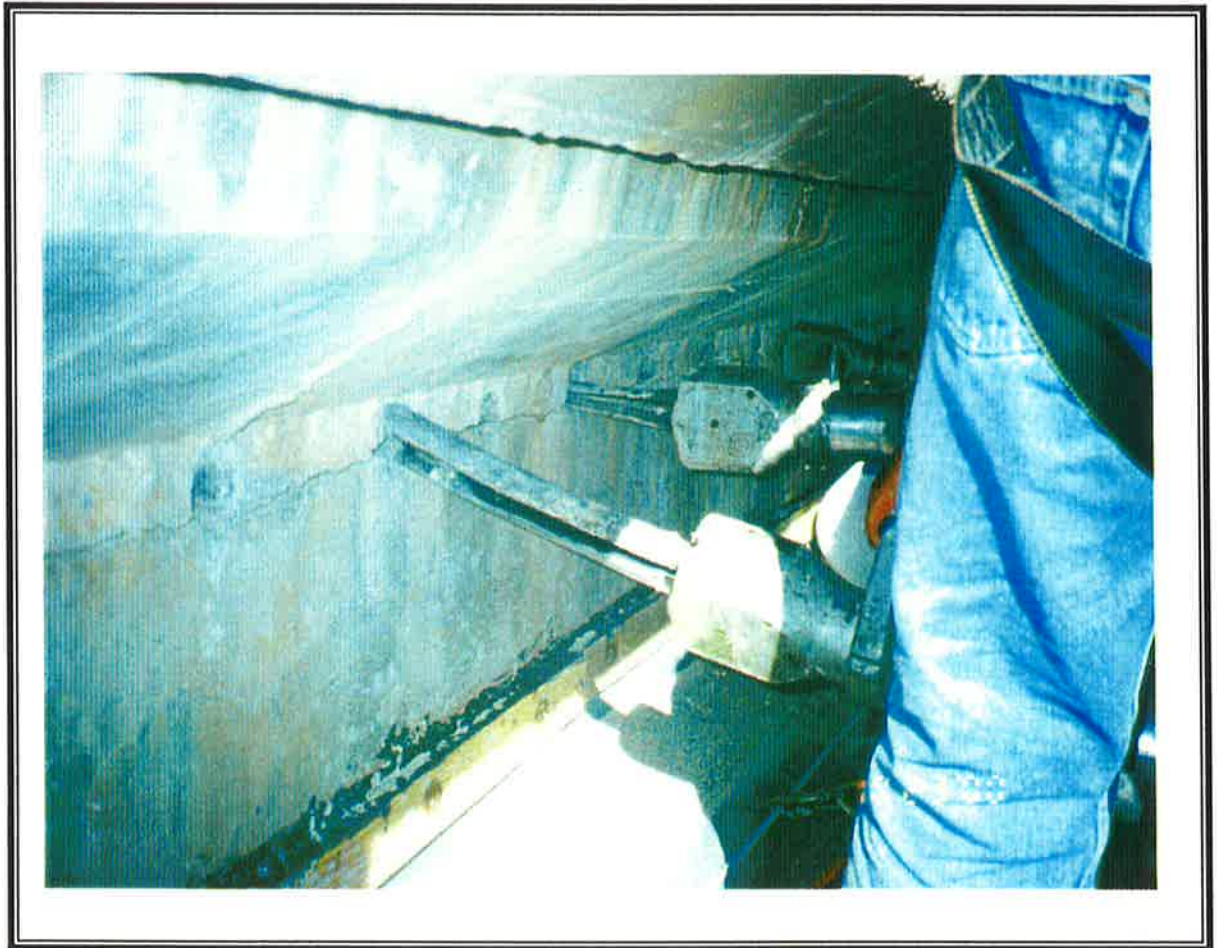
**Figure 5**

Hydraulic Splitting method being used to attempt a horizontal concrete cut.

The splitting method required the drilling of one- and one half-inch holes along the expected cut plane (approximately 12 inches apart, depending on the condition of the concrete). Usually splitters are inserted in pairs in adjacent holes, then activated to create pressure and break along the plane of least resistance. Three were used in adjacent holes in this trial, which would better the control of the cut (Figure 5). A 30-foot section of the dam was drilled in preparation for this method.

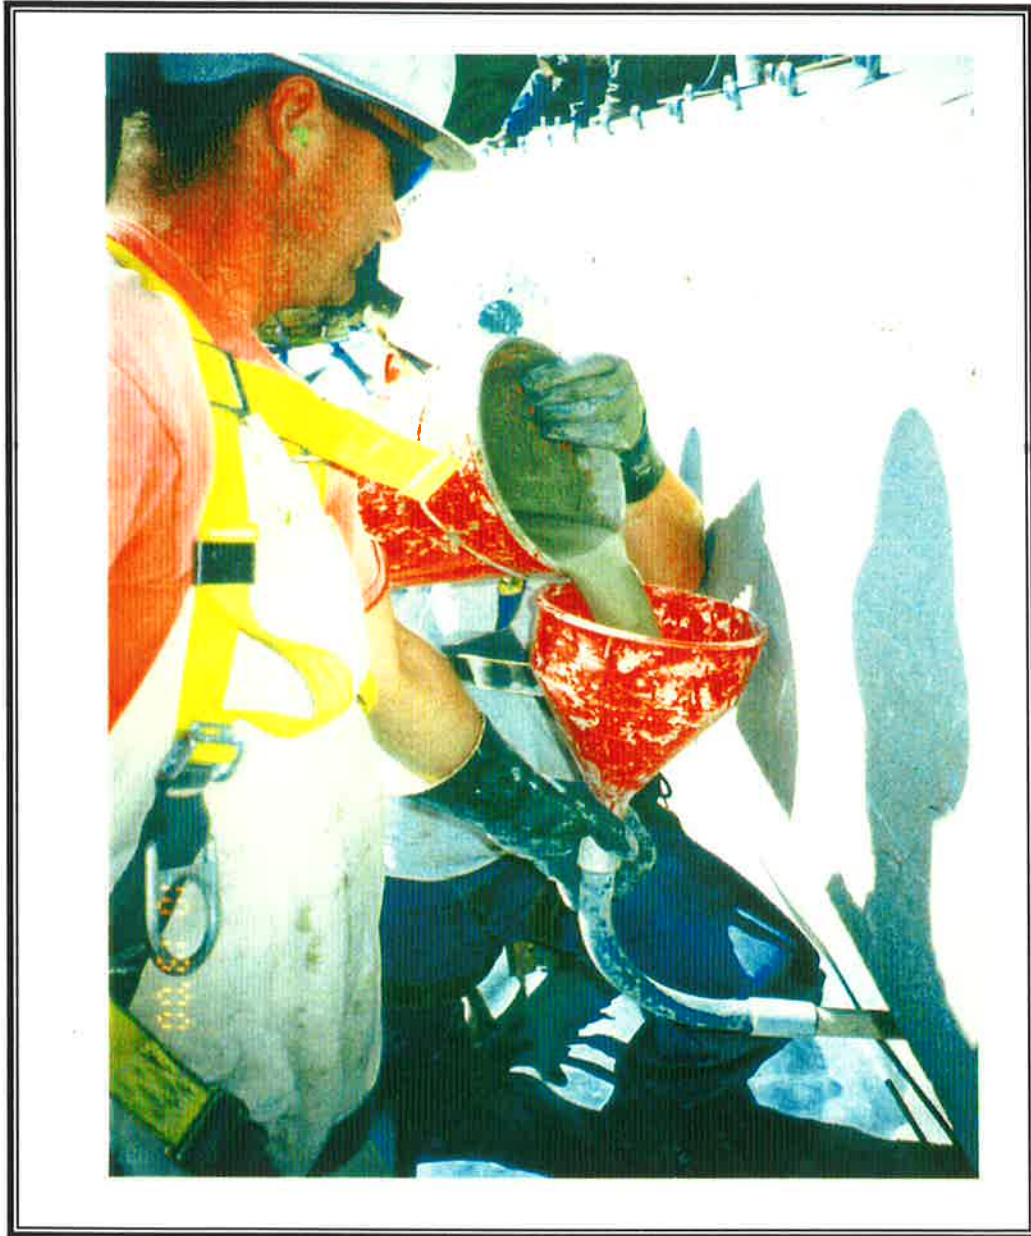
Figure 6

Expansive grout being inserted into horizontal holes  
for horizontal concrete separation.

The expansive grouting required the drilling of one- and one half-inch to two-inch holes every 28 inches horizontally through the dam face and approximately 12 inches apart vertically across the dam to provide cut planes. By design, the expansive grout, when inserted into the holes expands causing cracks along the drilled planes. The grout was mixed without special equipment, and was easy to insert, and cured in approximately 24 hours (Figure 6). Eyebolts were fixed to the block, which was expected to break away from the dam as a crane lifts the block.

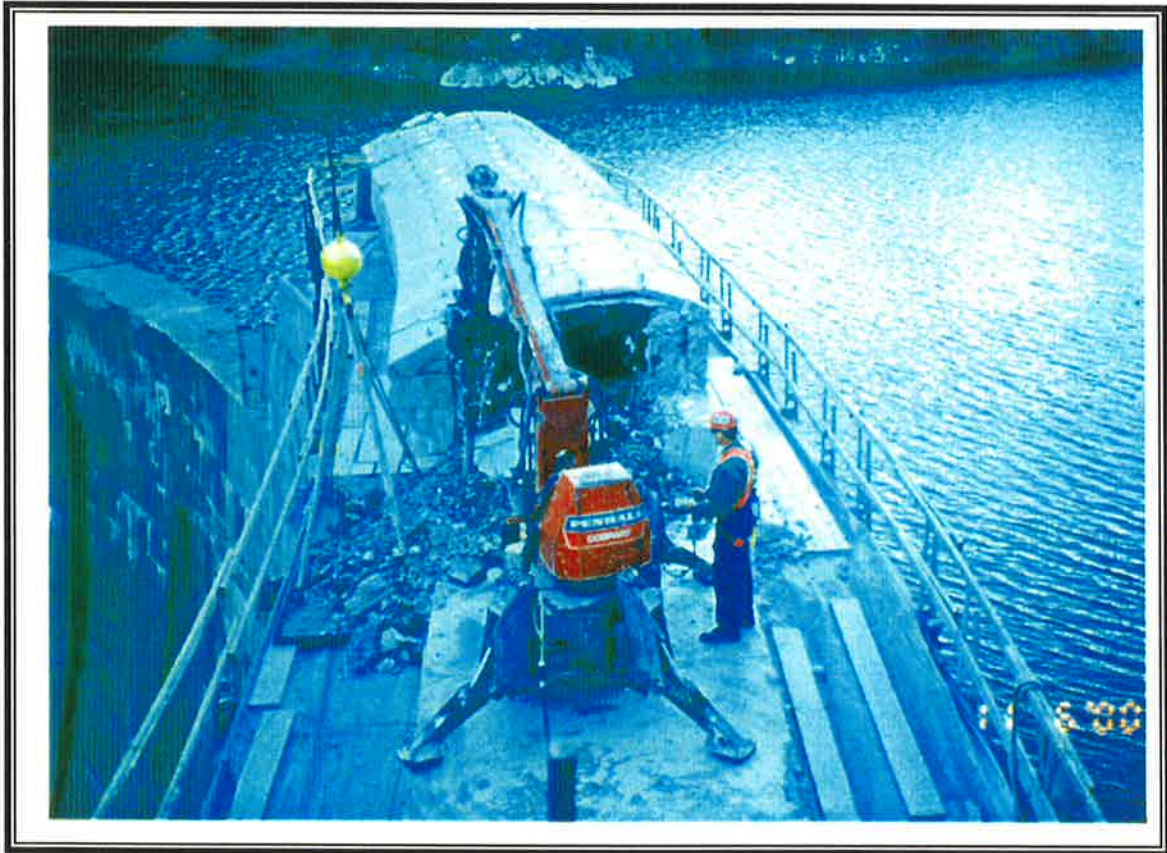
Figure 7

Pneumatic chipping operation being used to break concrete.

Pneumatic chipping originally was not considered a feasible method to use for the demonstration project, due to the larger dust particles produced with the operation. Containment of dust and debris was considered infeasible. However, this method proved to be very effective in removing the dam concrete (Figure 7). A 15-foot section of the dam was removed in 3 days or 5 feet/day using a hoe-ram. Water was used to contain the dust and debris chips, which was effectively contained by a plastic catchment system. The pieces of concrete were small and easy to place in a metal tray for removal via the crane to a temporary stockpile site. The rebar required cutting as the hoe-ram broke through the concrete, as with most of the other methods attempted during the project.
